ASPHALT TECHNOLOGIES, INC.

TEST & EVALUATION REPORT Shingle Rejuvenator Benchmark Life-Cycle Study

July 6, 2023

Report For: Greener Shingles Rejuvenator
Saskatchewan, Canada

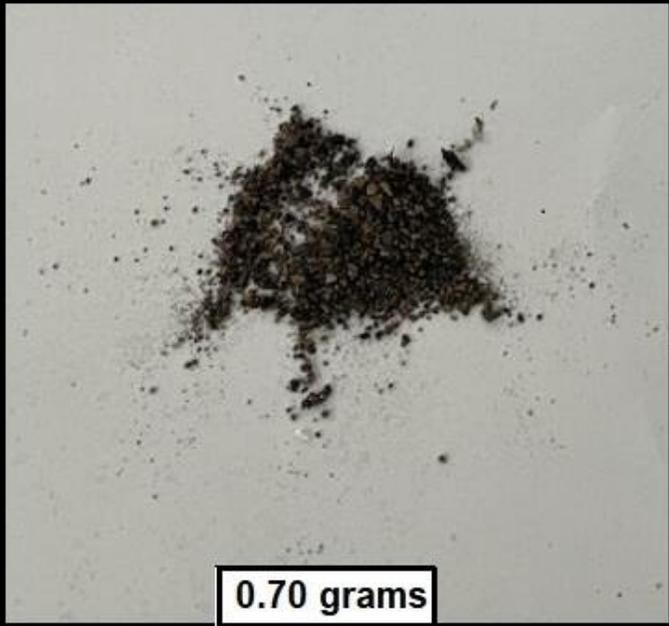
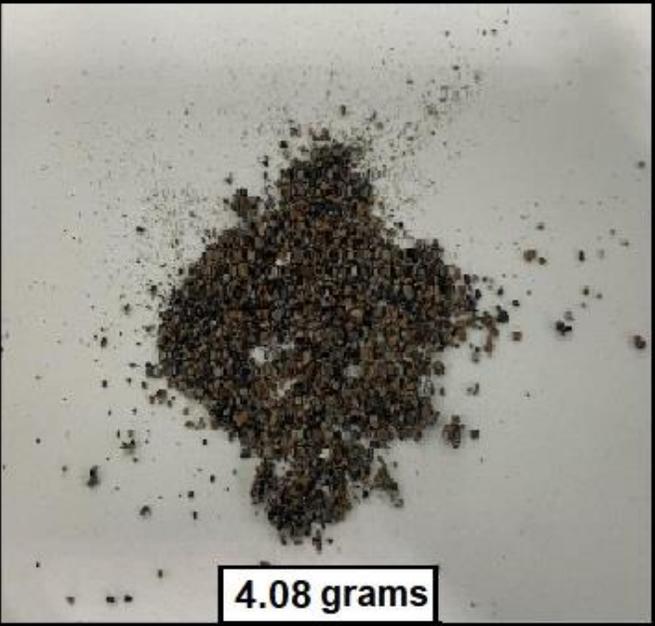
APPENDIX A-6 (Granular Wash off Comparison – ~1500 hours):

Greener Shingles Rejuvenator	Un-Treated Shingles

<div style="border: 1px solid black; padding: 2px; width: fit-content; margin: 0 auto;">0.70 grams</div>

<div style="border: 1px solid black; padding: 2px; width: fit-content; margin: 0 auto;">4.08 grams</div>

Granules and particulate washed from the roof decks after 1500 hours of exposure. Particles have been filtered from the accompanying runoff water and dried for quantification.

- **Wash off Material:** The exposure cycles consistently contained particulate material and shingle granules that were washed off by the accelerated weathering process.

- After 1,500 hours of exposure the mass of the collected particulate from the un-treated shingles was 4.08g compared to 0.70g for the Greener Shingles' rejuvenator.

- **Greener Shingles Rejuvenator performs 5.8 times better than un-treated shingles**
- **Oxidative Aging** (Measured by Carbonyl Indices): Oxidative aging in asphalt-based products can be quantified by a peak in a specific position on an FT-IR spectrum.
